**Flood Control Project Maintenance  
Levee Inspections**

**Fall 2018 Levee Maintenance Deficiency Summary Report**

**LMA District Cover Sheet**  
**Fall 2018 Levee Inspection Results**

**Sutter Maintenance Yard Maintenance Area 0005**

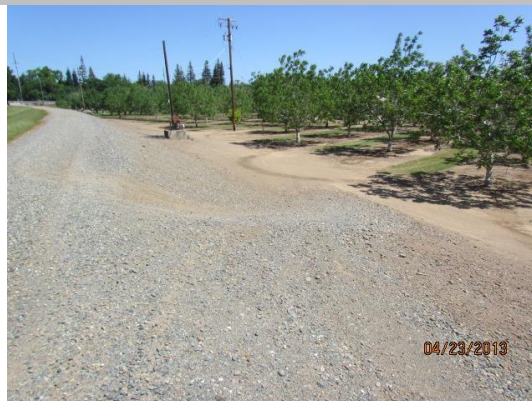
Photo 1 of 1 : FA\_2018\_MA0005\_196\_16\_20180905\_00006.jpg

LM Start	1.61	Rating **	M	Issue No.	16
LM End	1.61	Issue Type +	Ma	Location *	LS
Category	Earthen Levee			GPS Latitude/Longitude	
				Start	End
Item	Slope Stability			39.676129°	39.676129°
				-121.778171°	-121.778171°
DWR ID	DWR_MA0005_01_s_2013_16				
Comment Code					
S3 : Repair the levee slope damaged by vehicle traffic and prevent access where possible.					
Inspector Comment

View of the unauthorized vehicle ramp on the landside slope.

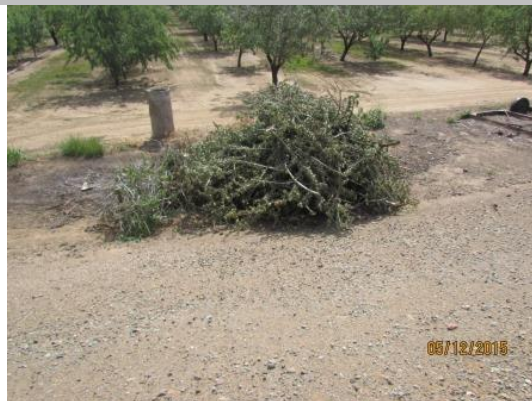
Photo 1 of 1 : FA\_2018\_MA0005\_196\_28\_20180905\_00009.jpg

View of the prunings along the landside toe.

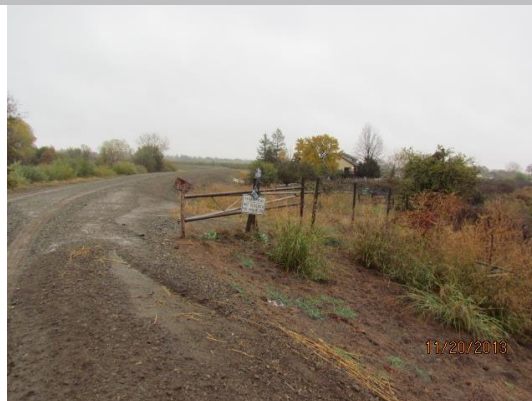
Photo 1 of 1 : FA\_2018\_MA0005\_196\_10\_20180905\_00005.jpg

LM Start	2.09	Rating **	M	Issue No.	10
LM End	2.09	Issue Type +	En	Location *	LS
Category	Earthen Levee			GPS Latitude/Longitude	
				Start	End
Item	Encroachments			39.670112 °	39.670112 °
				-121.782012 °	-121.782012 °
DWR ID	DWR_MA0005_01_s_2016_10				
Comment Code					
FE : Fence					
Inspector Comment					
No permit was found for the gate.

View of the unpermitted gate.

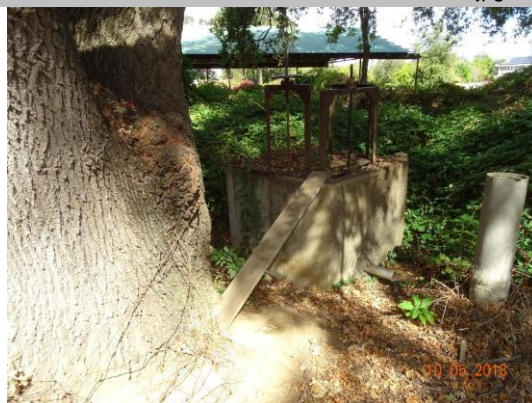
Photo 1 of 3 : UCIP\_FA\_2018\_53003\_78145.jpg

UCIP Comments: 10/5/2018 Observed pipe running during inspection. Pipe is used to drain water from LS concrete box to WS. Field structure description was updated to show structure type as drainage pipe. Confirmed that the concrete box on LS receives water from a pipe running along the LS toe from orchards upstream and distributes water between 3 pipes, one of which crosses levee at an angle. Missing closure device on WS. Screw gate stuck in open position inside CMP riser located on WS shoulder and is not operable. (O.Yakimov - DWR)5/15/2017 WS slide gate stem bent and gate is stuck in the open position. Outlet in the the concrete box on the WS berm is opened and allowed water to free flow through the pipe during the Jan/Feb 2017 high water events. Either the screw gate needs to be repaired or a flap gate added to the outlet in the concrete box to not allow high water flows though the levee. Pipe is believed to be owned and operated by Duhram Mutual Water Company at 1807 Duhram Dayton HWY, PO Box 612, Duhram CA 95938 (530)342-9324. (DWR Sutter Yard- AFreitag)

11/15/2016 Abandoned- slide gate is opened and inoperable. Needs to be properly abandoned. (DWR Sutter Yard- AFreitag)5/9/2016 Abandoned crossing. Slide gate stem bent and wheel is missing.8/5/2015 Abandoned crossing. Slide gate stem is bent and gate is inoperable. Needs to be properly abandoned.12/8/2014 Same as last inspection.6/11/2014 Same as last inspection.11/20/2013 Same as last inspection.5/29/2013 Same as last inspection.10/30/2012 Pipe appears to be abandoned. Slide gate open and inoperable. Pipe should be properly abandoned. FIELD\_STRUCT\_DESC: 30-inch corrugated metal drainage pipe through the levee, 10.5 feet below the crown. Slide gate in a corrugated metal riser on the waterside (WS) slope. Concrete distribution box on the landside (LS) toe and concrete overflow and siphon box at the edge of berm. [Additional Reference(s): DWR Levee Log, 1990. USACE Sacramento O&M Manual 516, April 1960 (Station 368+17)]. FS Date: 10/8/2018 2:06:36 PM

Concrete distribution box at LS toe.

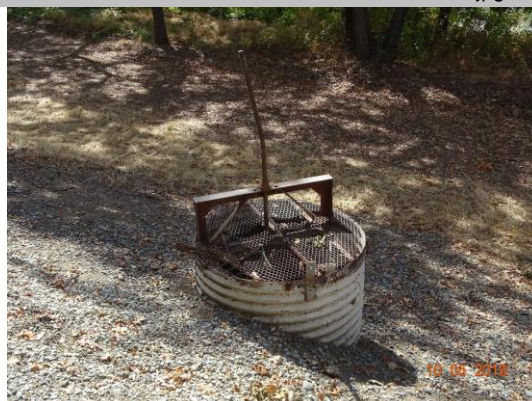
Photo 2 of 3 : UCIP\_FA\_2018\_53003\_78147.jpg

UCIP Comments: 10/5/2018 Observed pipe running during inspection. Pipe is used to drain water from LS concrete box to WS. Field structure description was updated to show structure type as drainage pipe. Confirmed that the concrete box on LS receives water from a pipe running along the LS toe from orchards upstream and distributes water between 3 pipes, one of which crosses levee at an angle. Missing closure device on WS. Screw gate stuck in open position inside CMP riser located on WS shoulder and is not operable. (O.Yakimov - DWR)5/15/2017 WS slide gate stem bent and gate is stuck in the open position. Outlet in the the concrete box on the WS berm is opened and allowed water to free flow through the pipe during the Jan/Feb 2017 high water events. Either the screw gate needs to be repaired or a flap gate added to the outlet in the concrete box to not allow high water flows though the levee. Pipe is believed to be owned and operated by Duhram Mutual Water Company at 1807 Duhram Dayton HWY, PO Box 612, Duhram CA 95938 (530)342-9324. (DWR Sutter Yard- AFreitag)

11/15/2016 Abandoned- slide gate is opened and inoperable. Needs to be properly abandoned. (DWR Sutter Yard- AFreitag)5/9/2016 Abandoned crossing. Slide gate stem bent and wheel is missing.8/5/2015 Abandoned crossing. Slide gate stem is bent and gate is inoperable. Needs to be properly abandoned.12/8/2014 Same as last inspection.6/11/2014 Same as last inspection.11/20/2013 Same as last inspection.5/29/2013 Same as last inspection.10/30/2012 Pipe appears to be abandoned. Slide gate open and inoperable. Pipe should be properly abandoned. FIELD\_STRUCT\_DESC: 30-inch corrugated metal drainage pipe through the levee, 10.5 feet below the crown. Slide gate in a corrugated metal riser on the waterside (WS) slope. Concrete distribution box on the landside (LS) toe and concrete overflow and siphon box at the edge of berm. [Additional Reference(s): DWR Levee Log, 1990. USACE Sacramento O&M Manual 516, April 1960 (Station 368+17)]. FS Date: 10/8/2018 2:06:36 PM

CMP riser with slide gate on WS shoulder. Notice bent screw in open position.

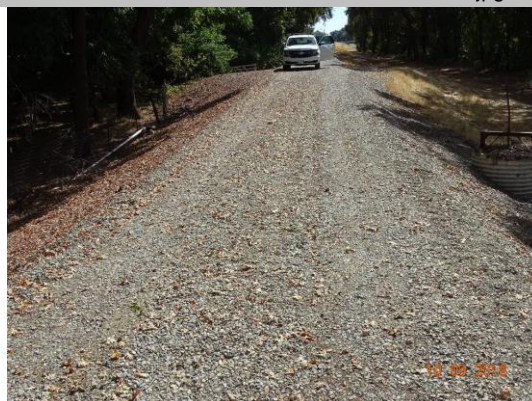
Photo 3 of 3 : UCIP\_FA\_2018\_53003\_78148.jpg

View of levee crown at crossing.

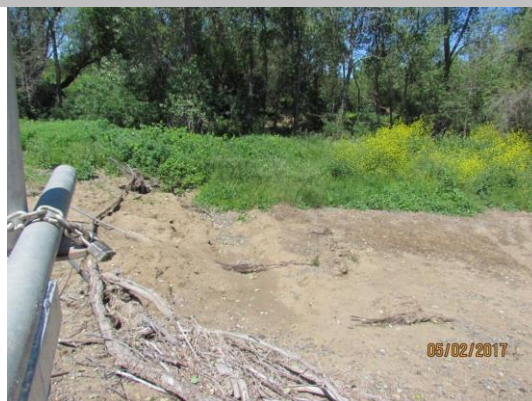
Photo 1 of 1 : FA\_2018\_MA0005\_196\_67\_20180905\_00032.jpg

View of erosion along the waterside slope.

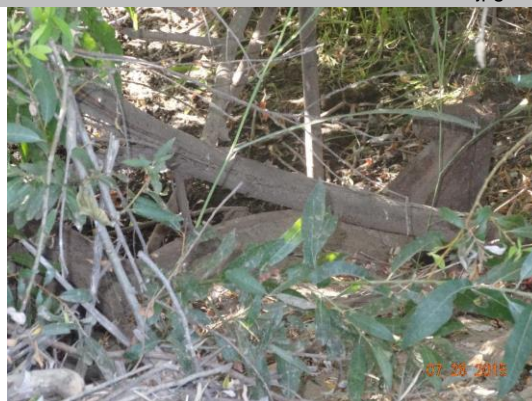
Photo 3 of 3 : UCIP\_FA\_2018\_53009\_74600.jpg

WS flap gate overgrown with vegetation.

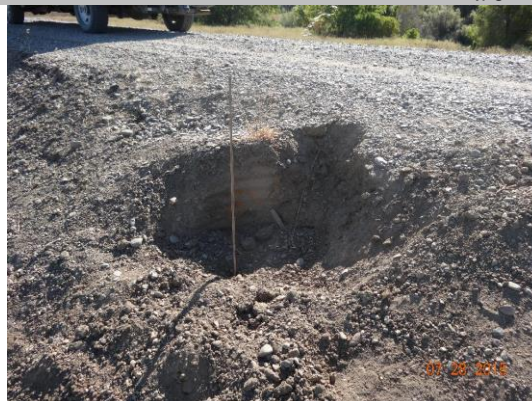
Photo 3 of 3 : UCIP\_FA\_2018\_52013\_74602.jpg

Spot where CMP riser was on the LS shoulder.

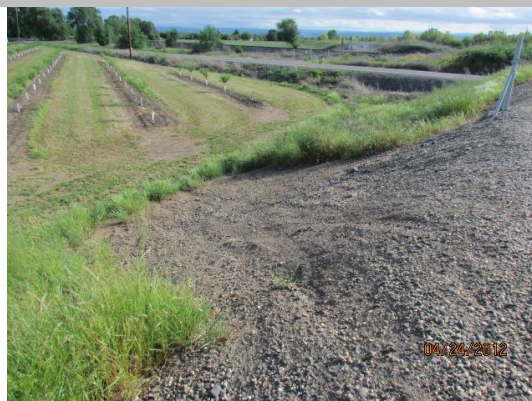
Photo 1 of 2 : FA\_2018\_MA0005\_197\_13\_20180905\_00005.jpg

View of the vehicle erosion along the slope.

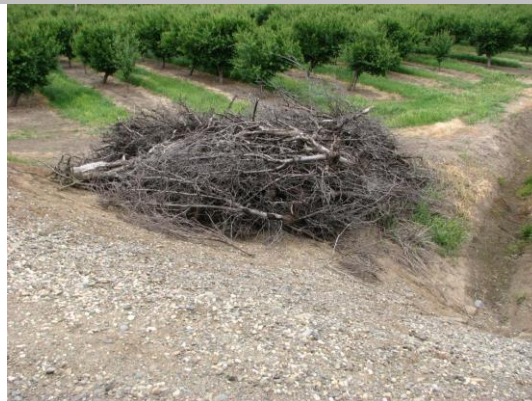
Photo 1 of 1 : FA\_2018\_MA0005\_197\_46\_20180905\_00021.jpg

View of the prunings along the landside toe.

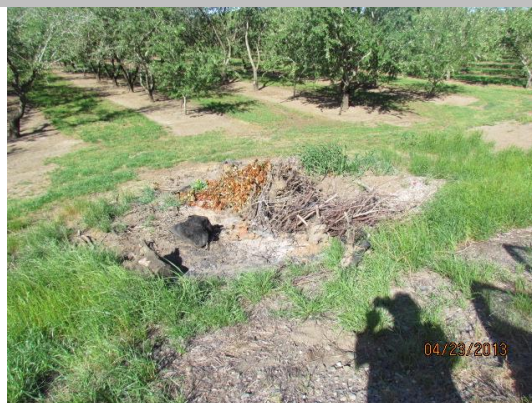
Photo 1 of 1 : FA\_2018\_MA0005\_197\_3\_20180905\_00002.jpg

View of the prunings along the landside toe.

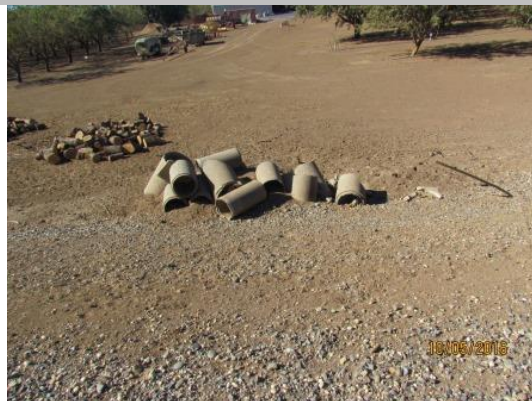
Photo 1 of 1 : FA\_2018\_MA0005\_197\_57\_20180905\_00029.jpg

View of the broken concrete pipes and firewood along the landside toe.

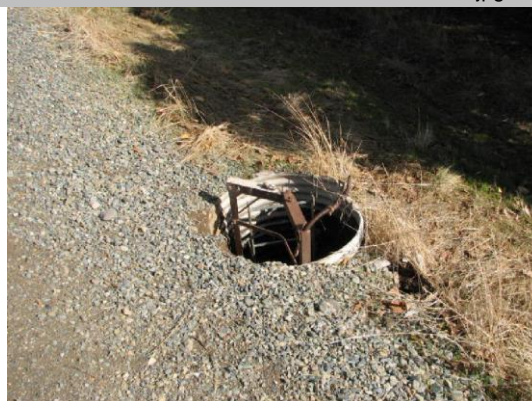
Photo 1 of 3 : UCIP\_FA\_2018\_52072\_68465.jpg

Broken slide gate in CM riser on WS slope.

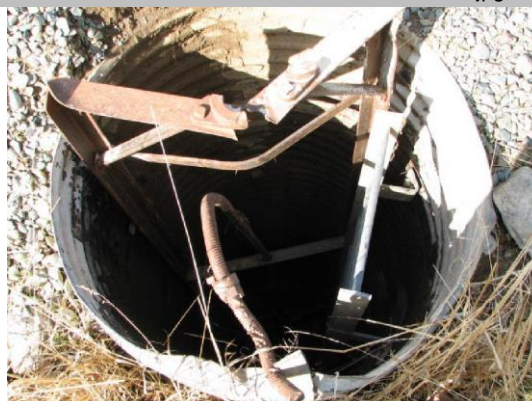
Photo 3 of 3 : UCIP\_FA\_2018\_52072\_68463.jpg

Broken slide gate in CM riser on WS slope.

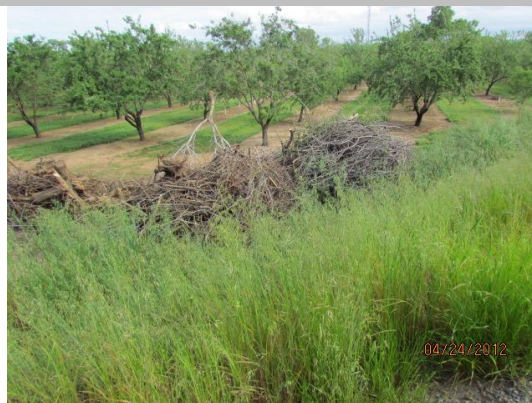
Photo 1 of 1 : FA\_2018\_MA0005\_197\_19\_20180905\_00008.jpg

View of the prunings at the toe of the levee.

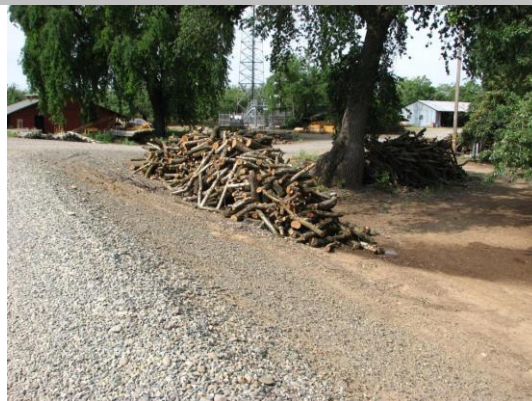
Photo 1 of 1 : FA\_2018\_MA0005\_197\_42\_20180905\_00018.jpg

View of the firewood pile at the landside toe.

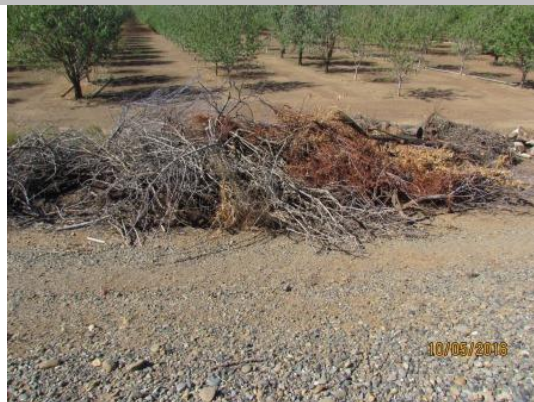
Photo 1 of 1 : FA\_2018\_MA0005\_197\_61\_20180905\_00032.jpg

View of the prunings along the landside toe.

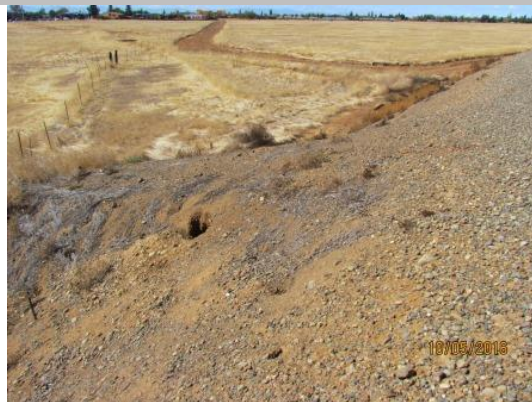
Photo 1 of 1 : FA\_2018\_MA0005\_197\_39\_20180905\_00015.jpg

View of the rodent holes along the landside slope.
